Roe Boulevard Traffic Study

Roe Boulevard

Traffic Study

September 2016

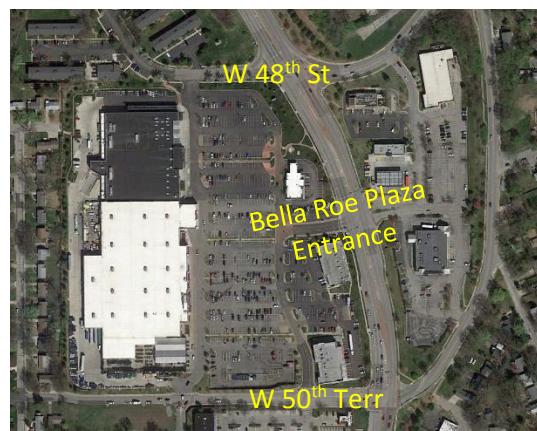
Figure 2 - Bella Roe Plaza Entrance Arial

Peak evening counts were collected on Tuesday, July 26th. The intersection, location shown in Figure 2, was observed to function as needed. There were no noticeable problems with the traffic signal or intersection itself, but the signal disrupts the flow of northbound and southbound traffic, which carry the majority of the vehicles. Figure 3 shows the

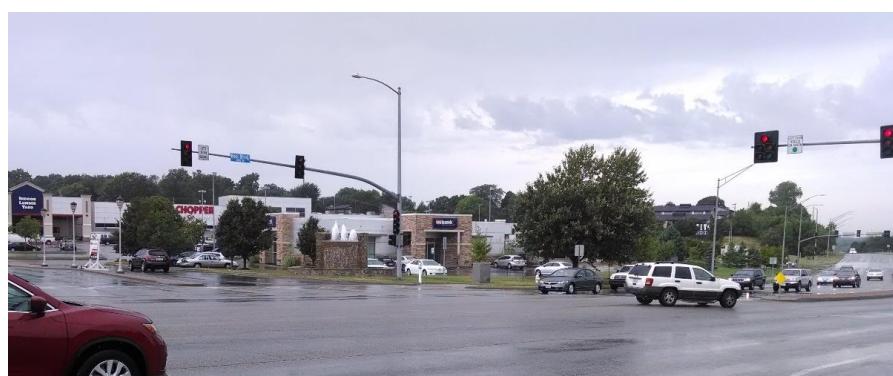
Figure 3 - Bella Roe Plaza Entrance and Roe Blvd

- Southbound vehicles, when stopped at Bella Roe Plaza, back up into the intersection of W 48th Street during peak evening hours.

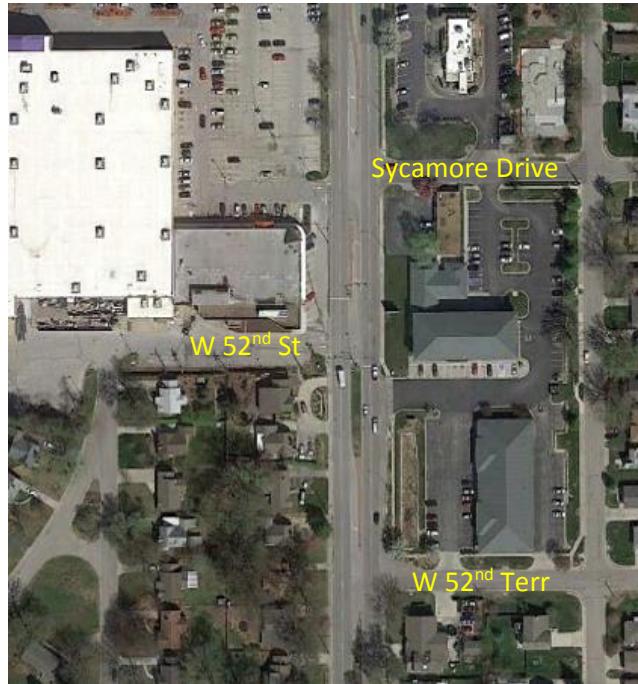
Figure 4 – W 52nd Street Aerial

Videos for the traffic count and observation of this intersection were completed on July 28th, a Thursday. The location of the W 52nd Street and Roe Boulevard is shown below in Figure 4 and Figure 5 is an image taken of the intersection from W 52nd Street facing east. The following was observed.
